**DRAFT MINUTES OF THE COMMUNITY SERVICES COMMITTEE MEETING  
HELD ON 6<sup>th</sup> SEPTEMBER 2022  
AT 7:45 PM AT THE RUFUS CENTRE**

- 1.3 Chris Burnett Associates (CBA) were commissioned in March 2022 to prepare a Parkland Management Plan (PMP) for Flitwick Manor Park by Flitwick Town Council. The principal objectives were concerned with establishing and conserving the historic integrity and legibility, recreation, education and wildlife interests of the park and also integrating the views and vistas across the site between the formal gardens in ownership of the hotel and the land in ownership of the Flitwick Town Council. Various features within the park have fallen into neglect, such as the lake known as Flit Water, the ha-ha and Lower Lodge gateway. Examining options to restore them are a priority of the plan. Some areas of the park also appear to suffer from over-use (in particular the northwest of the lake) whilst the area to the southeast is less utilised and the 'story' that the park tells is in danger of becoming fragmented even within the area of Town Council ownership. The 'loss' of the formal gardens and house amplifies this fragmentation, although the house can stil

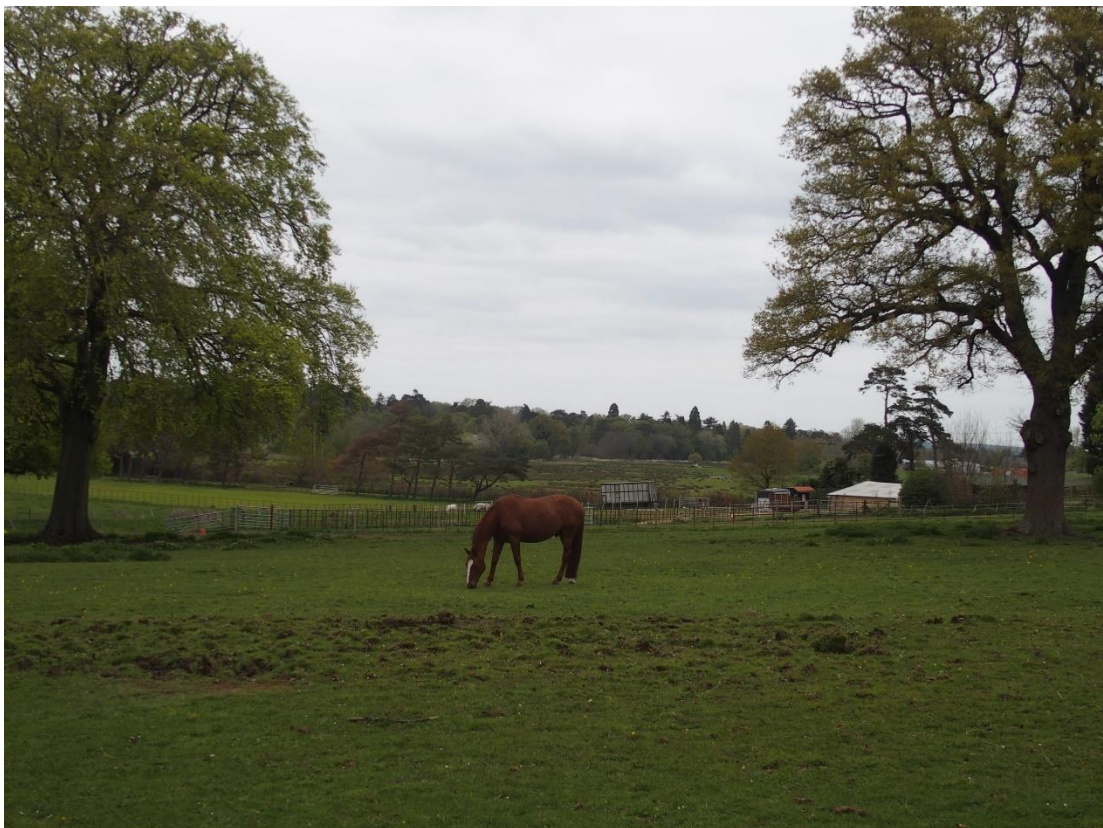
2.7 Flitwick Manor park is situated on the immediate outskirts of Flitwick which lies to the north east. The town, however, is largely screened from view due the presence of perimeter belts of mature woodland and the Arboretum. A self enclosed green space results. The Park is easily identifiable from a distance as the mature conifers, which make such a contribution to its character, become a notable feature of the skyline see photograph below:

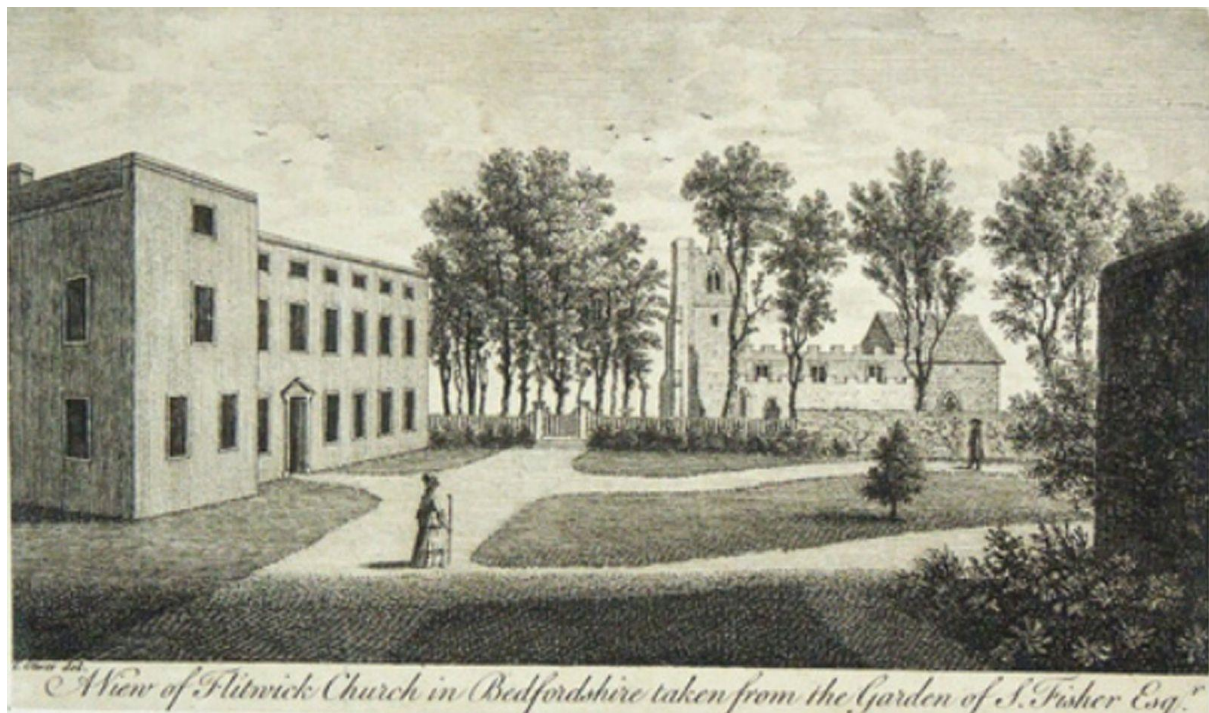
Fig 4.2 A View of Flitwick Church in Bedfordshire taken from the Garden of J Fisher Esq., Building on right possibly a ruin?

- 4.5 Dell died in 1765 and Ann Fisher, his god daughter, inherited the estate. There is no information about changes in the landscape during the period of her ownership. She was still a minor when she inherited. [ born 1757] so management fell to her father. A single image of the house and relationship to the church and its immediate setting survives for 1776 revealing that the property was of sufficient status at that date to appear in a publication<sup>8</sup> as well as, in part, the layout around the house. ( see Fig 4.2)

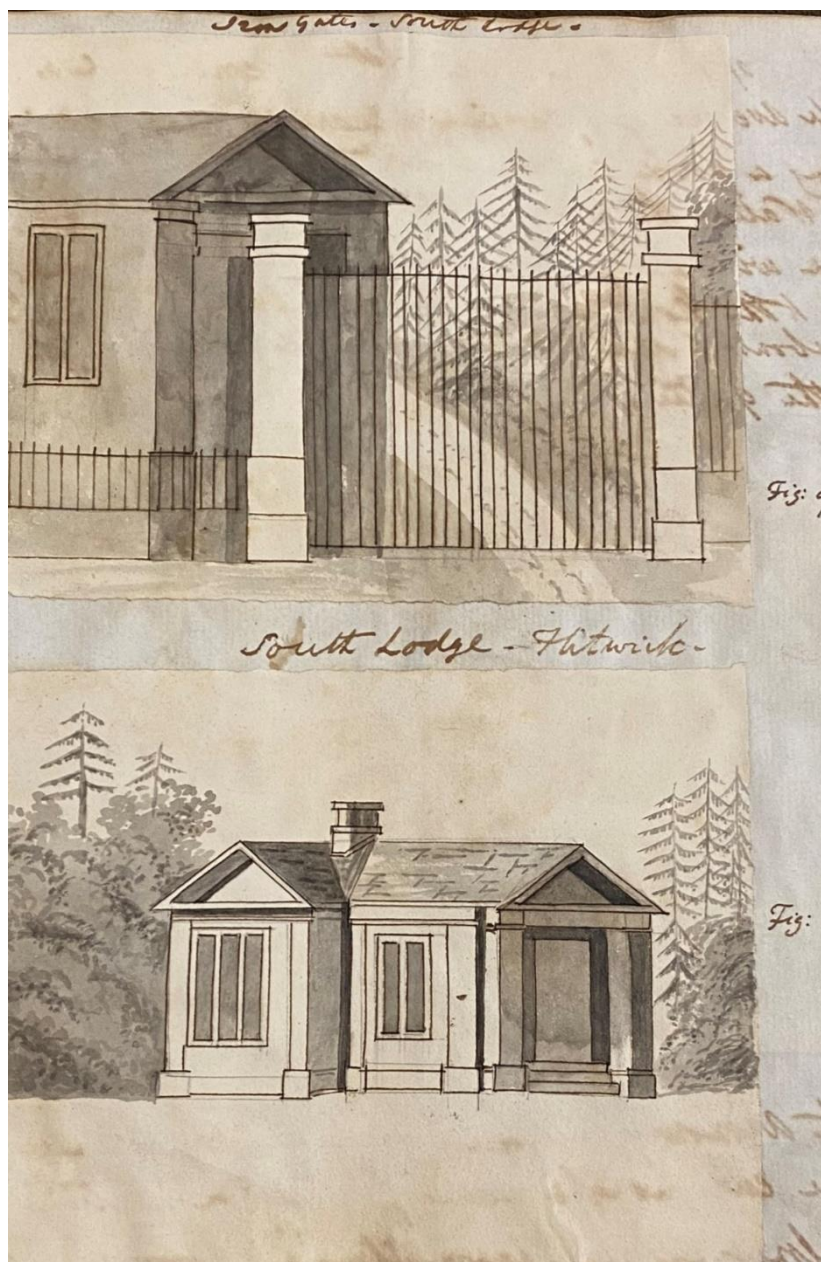
**Figure 4.6 Lower Lodge and gates**

- 4.19 The diagrammatic plan, Fig 4.4, shows that Brook's scheme extended south west towards the current Priestley Moor Plantation and between a field boundary and Flit Brook through this field he laid out his Pinetum. [28]. The pinetum comprised pines, firs, cedars and larches with a walk to it passing a summer seat marked as 28a . Adjacent was an area of specimens of birch and poplar, [29] next to this were single specimens of alder, [30] single specimens of willow [31] and towards the south, or Lower Lodge, an evergreen and deciduous plantation. [32 and 33]. The planting of most of this area has now gone reverting to meadow with the exception of the evergreens which formed the immediate setting of the south or Lower Lodge and its gates.

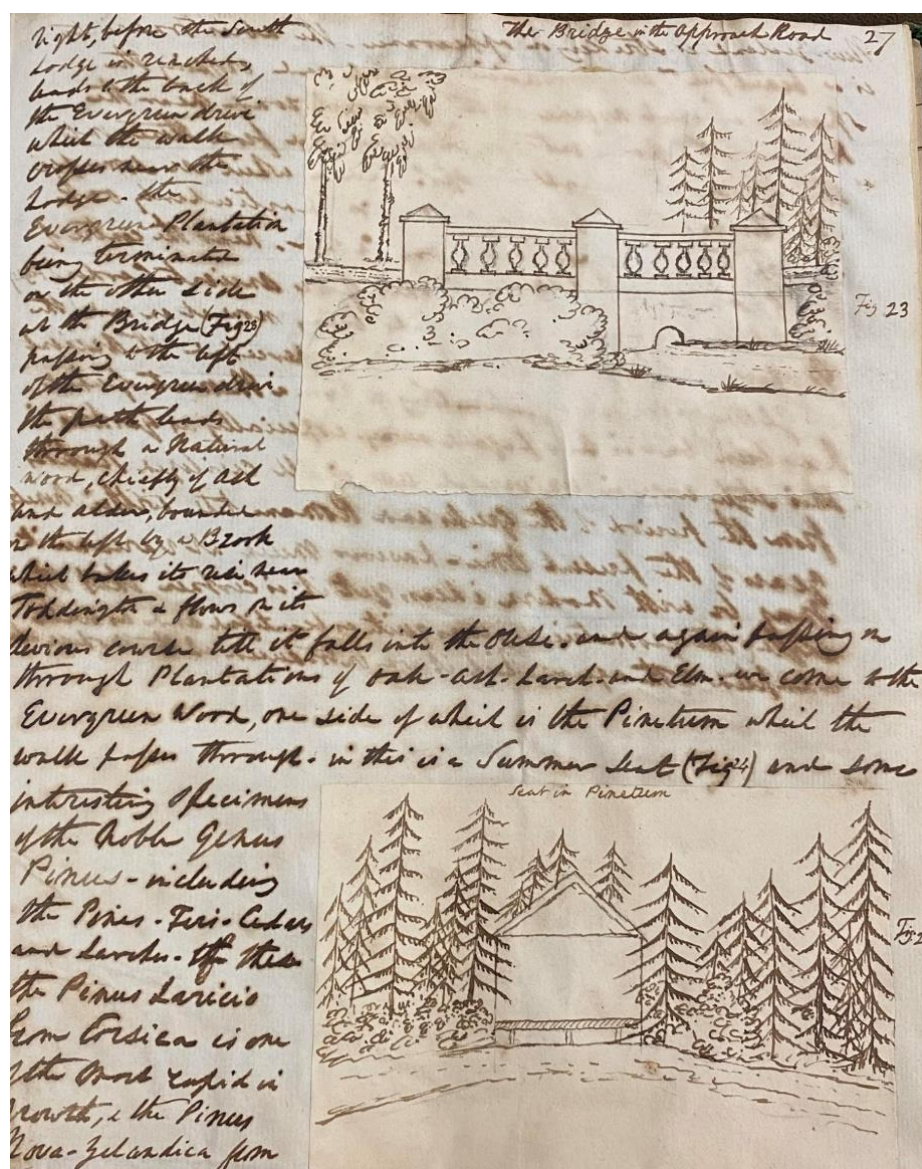
**Fig 4.8** Page from the manuscript book about the estate showing bridge [ above] and seat in Pinetum [below]

- 4.21 The drive to Lower Lodge and Gates passed through 34 and 35 to reach the Sweet Chestnut Avenue [15] over the bridge [38]. (See **Fig 4.8 bridge and seat** above). The description indicates that as well as an interest in the compartmented planting Brooks was also interested in the view and mentions the view into the Park / Home ground from a gap in the planting indicating this was contrived view point.

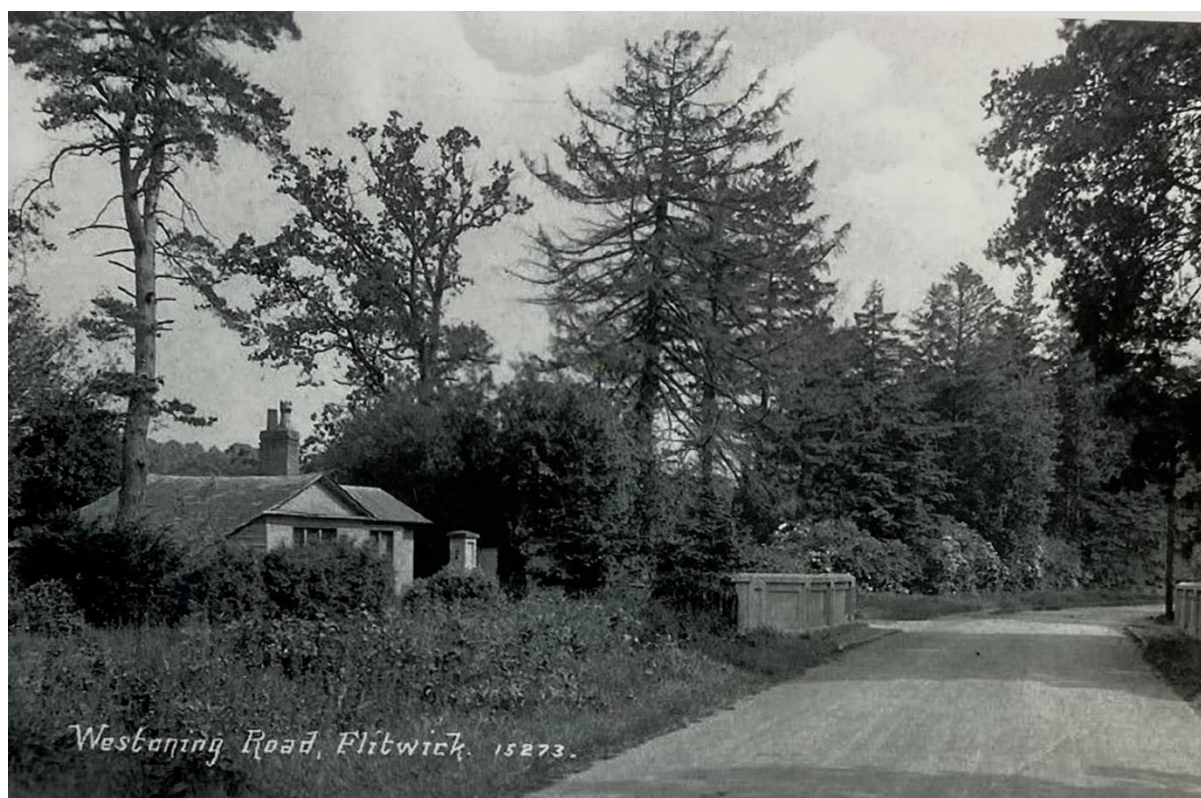
**Fig 4.11 Lower Lodge and setting c 1907 showing open nature of tree canopy**

- 4.33 John Hatfield Brooks generously opened the estate to the public for various events, such as local bazaars and it is clear that there was a head gardener [ H W Nutt] at least until 1893 who maintained the estate's gardens and pleasure grounds<sup>29</sup>. The Flit was used for ice skating in 1895 when frozen over<sup>30</sup>. Theatrical events were also held using the grotto as a back drop for performances.<sup>31</sup> A Horticultural Show was held in the grounds in 1904<sup>32</sup>. No new innovations in terms of development appear to have occurred in his lifetime. He died in 1907.

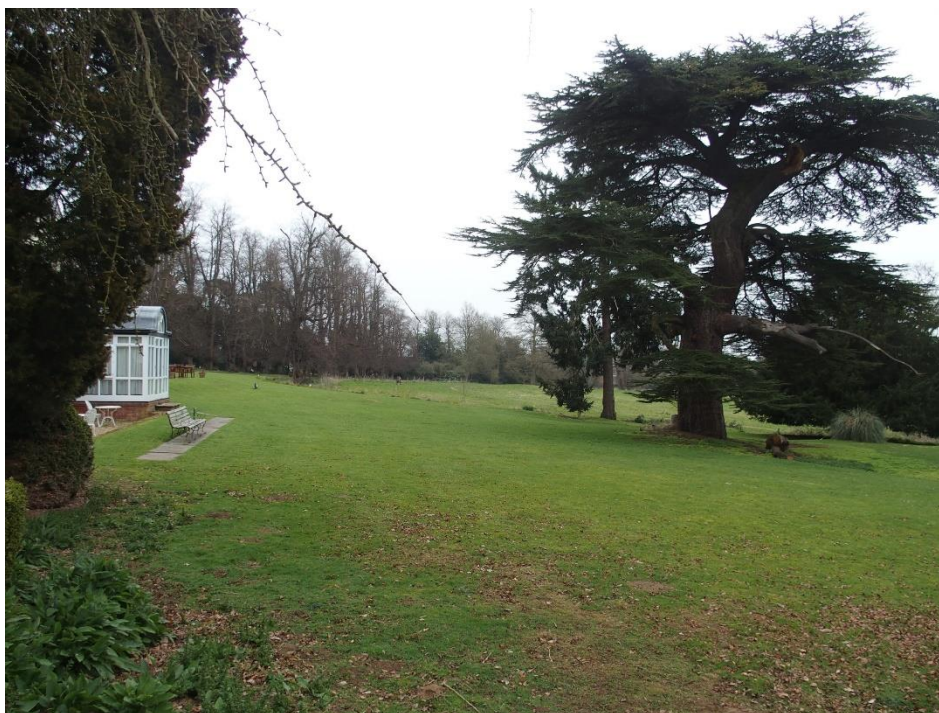
### House and gardens

- 5.3 In the ownership of Flitwick Manor Hotel this character area consists of formal tightly mown lawns, specimen mature trees, shrubbery, a formal lime avenue, a gravel parking area and garden buildings most of which are in good condition. Certain elements are, however in poor condition . These include the ha – ha ( detailed assessment of which is found in section 8.0) and which is subject to sporadic growth of naturally regenerating trees, the Grotto, ( outside the scope of this study) and the post and wire boundary fence which separates the gardens from the park.

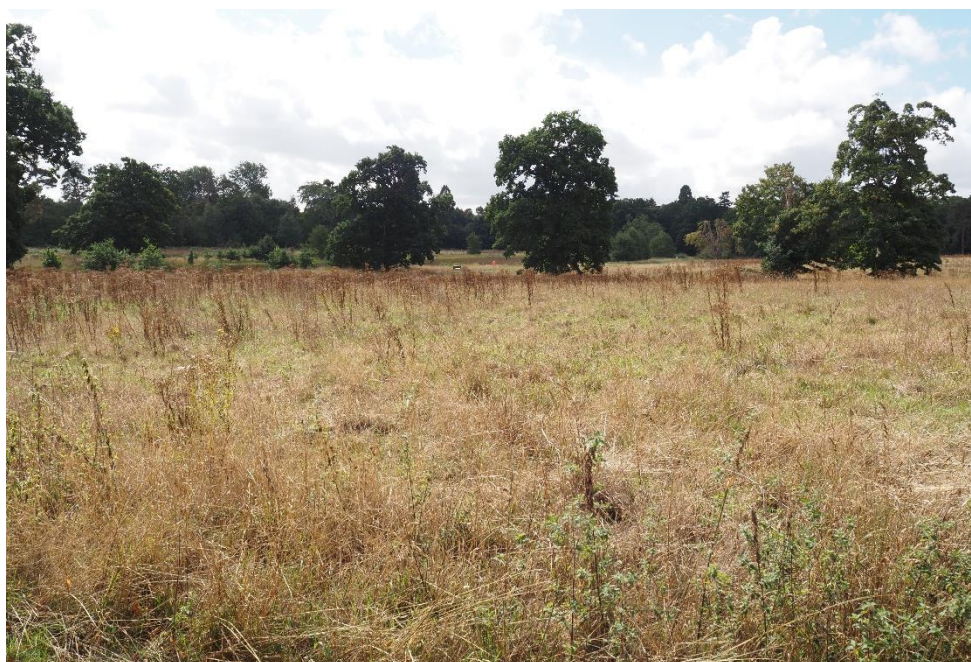
## Parkland

- 5.4 An open area of grassland which is cut once a year, apart from the field behind the lake which is grazed, this area is largely in good condition however it is under threat at the present time from a ragwort infestation which will need to be managed if it is not to get out of control. Generally, this area is in good condition but various elements are in poor condition. These include the state of some of the informal paths which are showing signs of erosion to bare earth, the margins or interface between the arboretum and parkland which looks to be unmanaged at present, the lake which is silted up and entirely vegetated and there are few young or recently planted parkland trees.

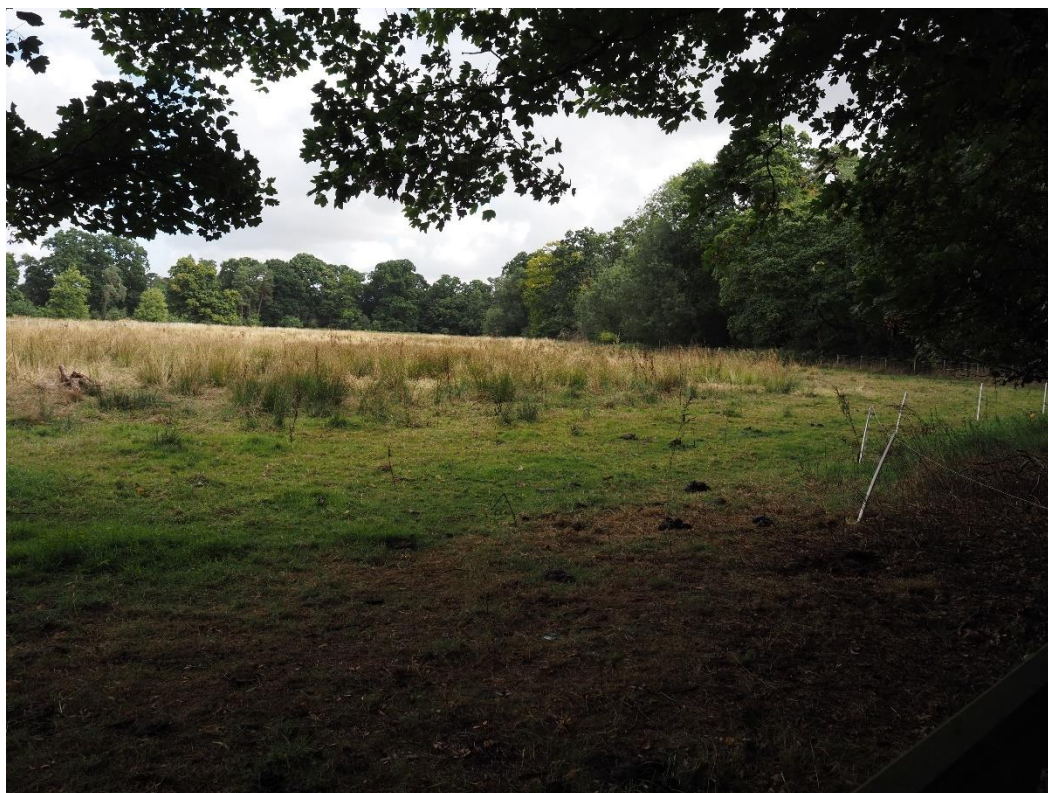
- 5.5 The centrepiece of the landscape at Flitwick, this area has developed into unmanaged woodland and its character has suffered as a result with natural regeneration of trees such as sycamore commonplace throughout. Most of the exotic conifers however are in good condition ( see tree survey Appendix 9A, B and C) Visibility and legibility are poor and there is no formal path network. The paths at the moment are bare soil. Overall therefore this feature is judged to be in poor condition and in need of restoration.
- 5.6 The same cannot be said for the belt of perimeter woodland which has fewer exotics and is more akin to a well structured, multi layered woodland with evidence of a vigorous shrub, understorey layers and a better age structure to the trees within it. It provides an important screening function in relation to Westoning road.

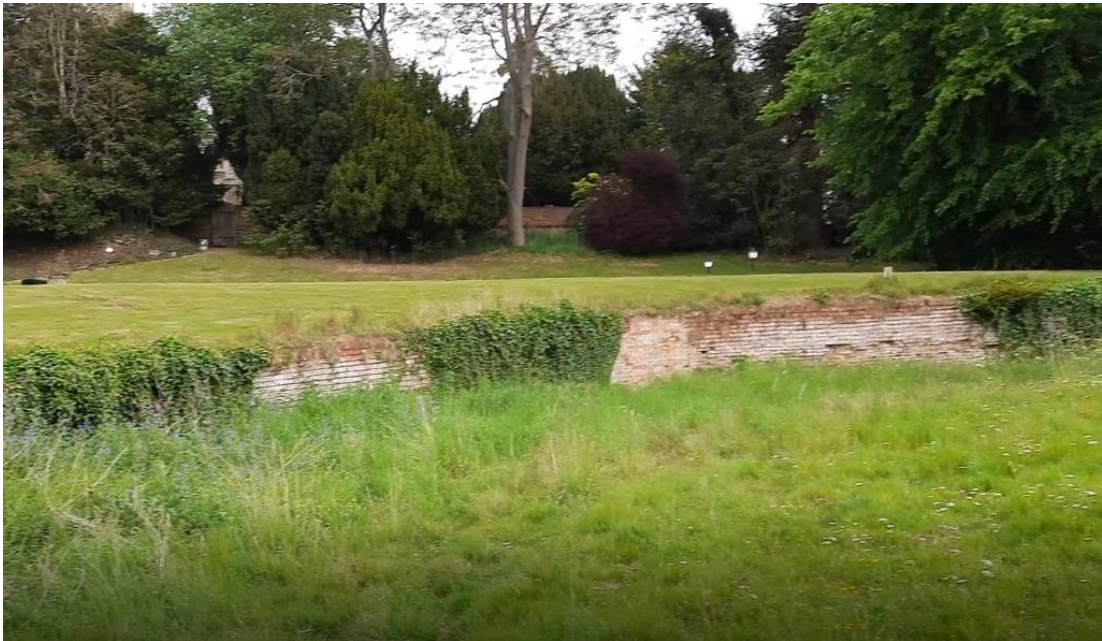
Fig 02 The Ha-ha

- 6.7 Where visible between the sections covered in vegetation, it is formed with a coping of soldier course brickwork, with an English Garden bond variant to the brickwork below (rows of stretchers between a row of headers). At the west end, it starts close to a young oak tree, tapering up as the ground levels diverge until it reaches its full height, 1.35m. This initial length is covered in dense vegetation including ivy and young trees. The Ha-Ha continues to the east at a constant height, and includes a short section that has been either rebuilt or heavily consolidated in the past, and ends in an area of dense vegetation adjacent to a mature lime tree growing out of the upper ground level.

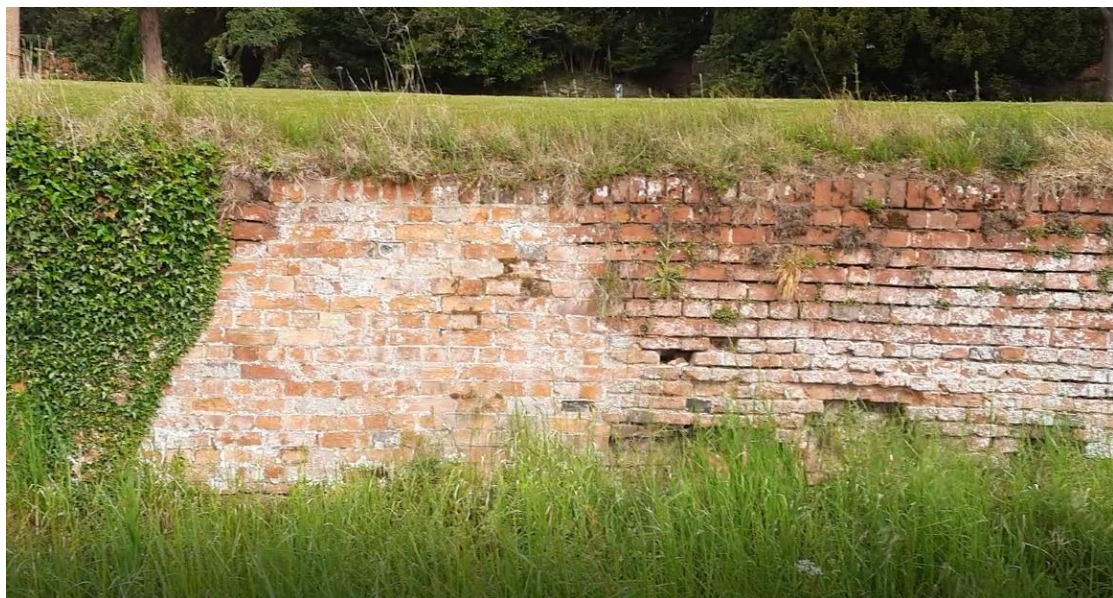
- Vegetation, including ivy and self-seeding trees growing close to and out of the structure. This both limits observation of the condition, and will also be causing deterioration.
- Open joints. Joints were open to up to 50mm in many places. Behind this, earth rather than mortar was seen.

Fig 03 - Ha-Ha, showing section that has been rebuilt/consolidated

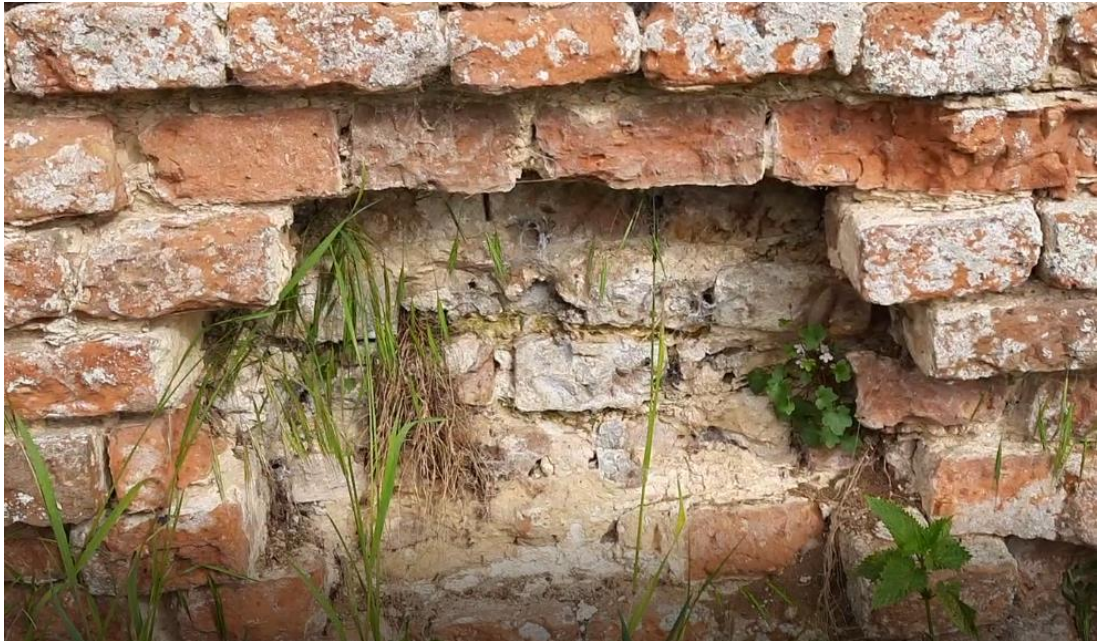
- Cavities to the brickwork and spalling of the outer face of bricks. These areas were typically seen low down, and are likely to have been caused by the action of vegetation and the free draining of water through the wall, with the mortar loss leading on to loss of bricks. Also, low down, these areas are more susceptible to the action of rain water splash back, and subsequent frost attack to the more saturated masonry.

Fig 04 - Ha-Ha, showing a cavity which is half a brick width deep

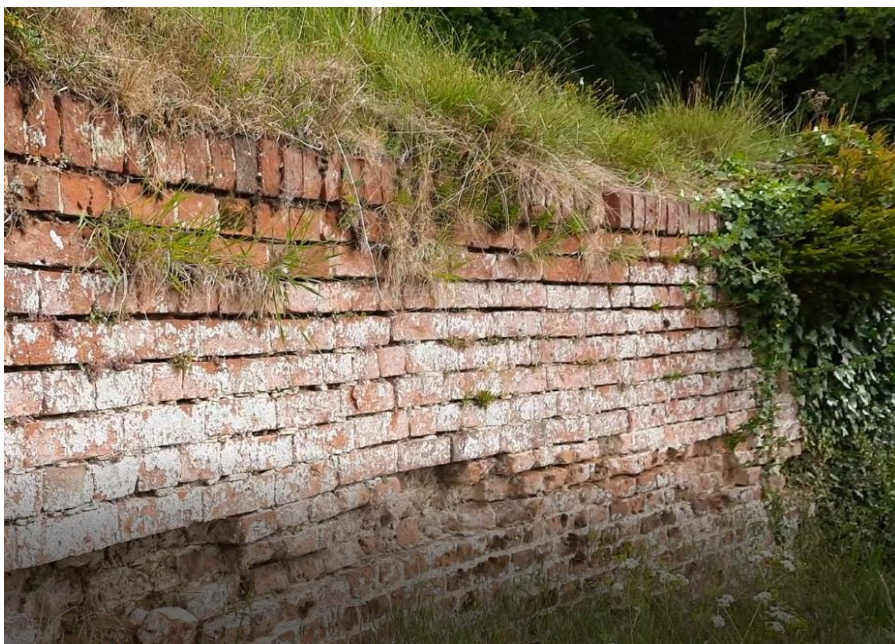
Fig 05 - Ha-Ha, showing cavities and open joints

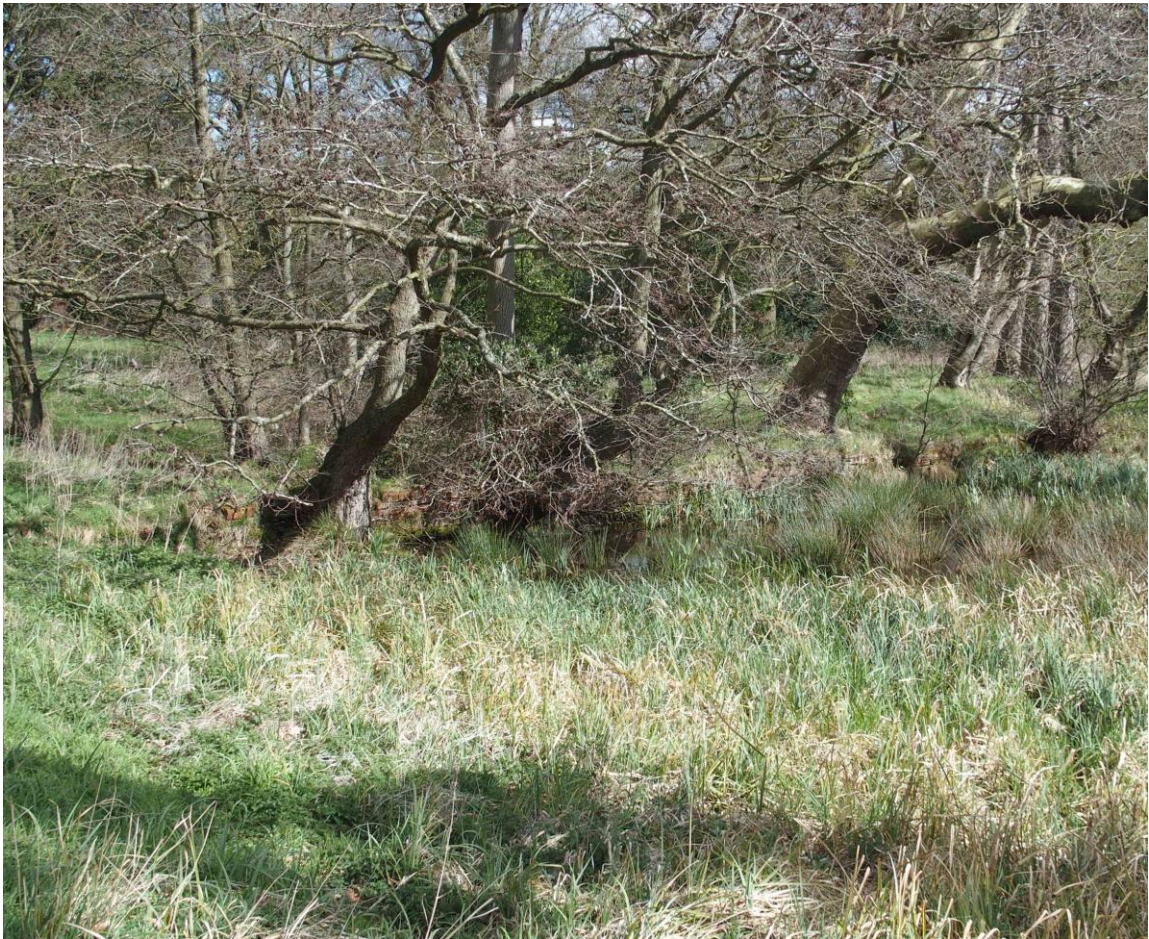
Fig 08 - The Cascade viewed from the park. Note the presence of semi mature and mature trees on cascade wall

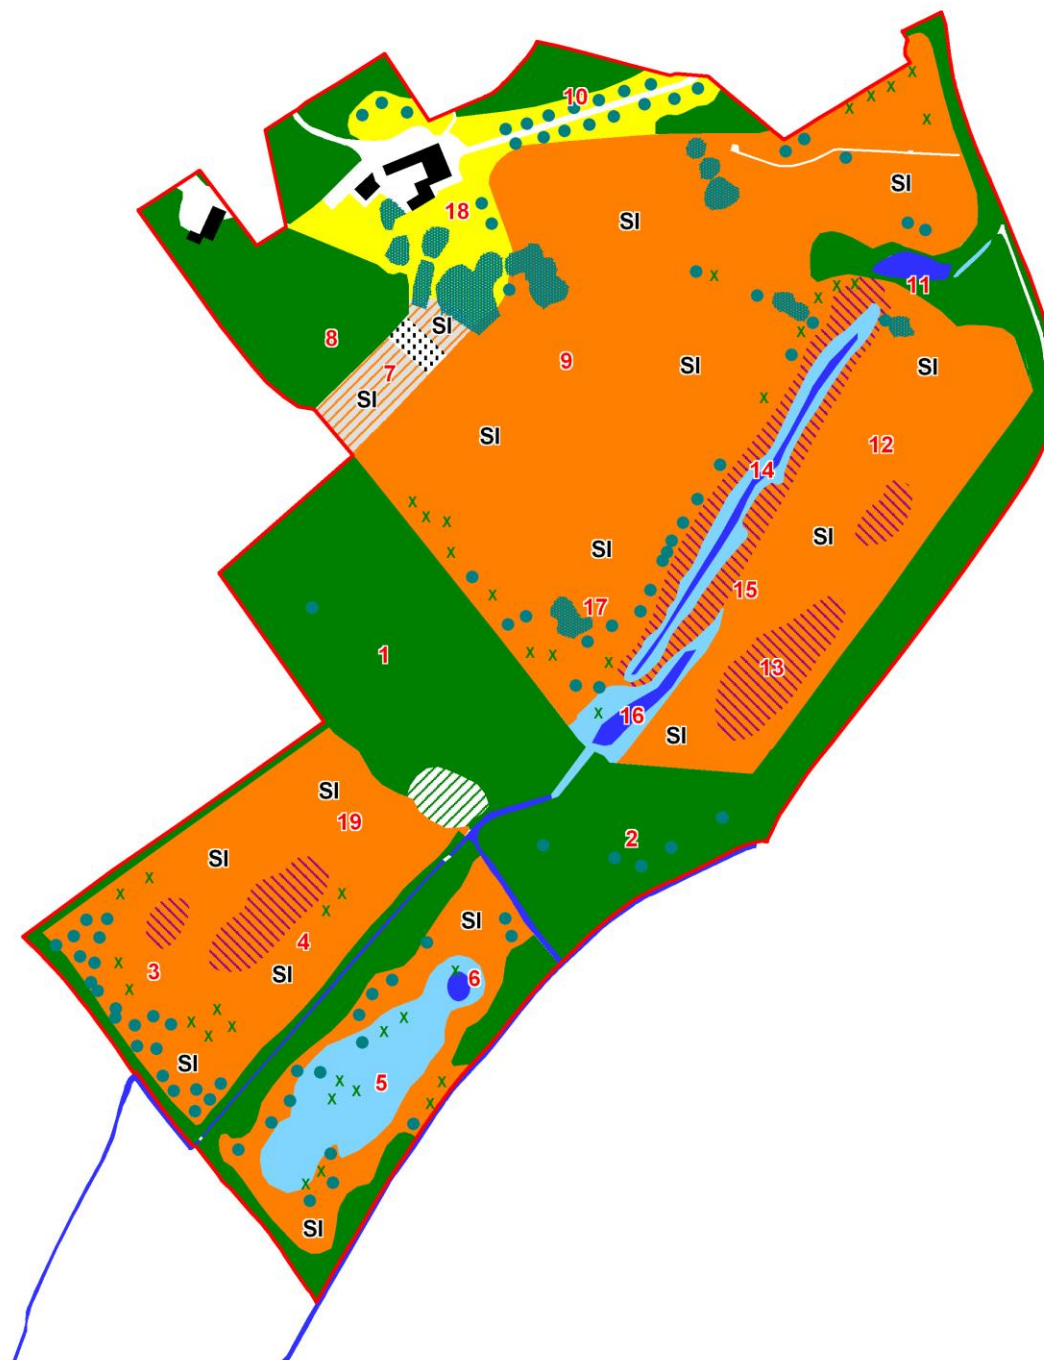
- 7.1 Flitwick Manor Park consists of c. 22ha of land on the southern edge of the town of Flitwick. It includes parkland, a lake, marshy grassland, veteran and specimen trees and woodland. The site is on the Register of Historic Parks & Gardens, listed as Grade II. Lowland wood pasture and parkland is a National Priority habitat in the UK Biodiversity Action Plan.
- 7.2 The site consists of c. 7 ha of parkland containing a 1 ha lake (Flit Water) and an area of marshy grassland; c. 5 ha of mature woodland; and two fields containing further areas of semi-improved marshy grassland. The total area of marshy grassland is c. 7 ha.
- 7.3 A habitat survey was carried out in May 2022 and notes made below which are linked to See **Fig 7.1 Habitat Map** and to a series of observations and recommendations on management which follow.

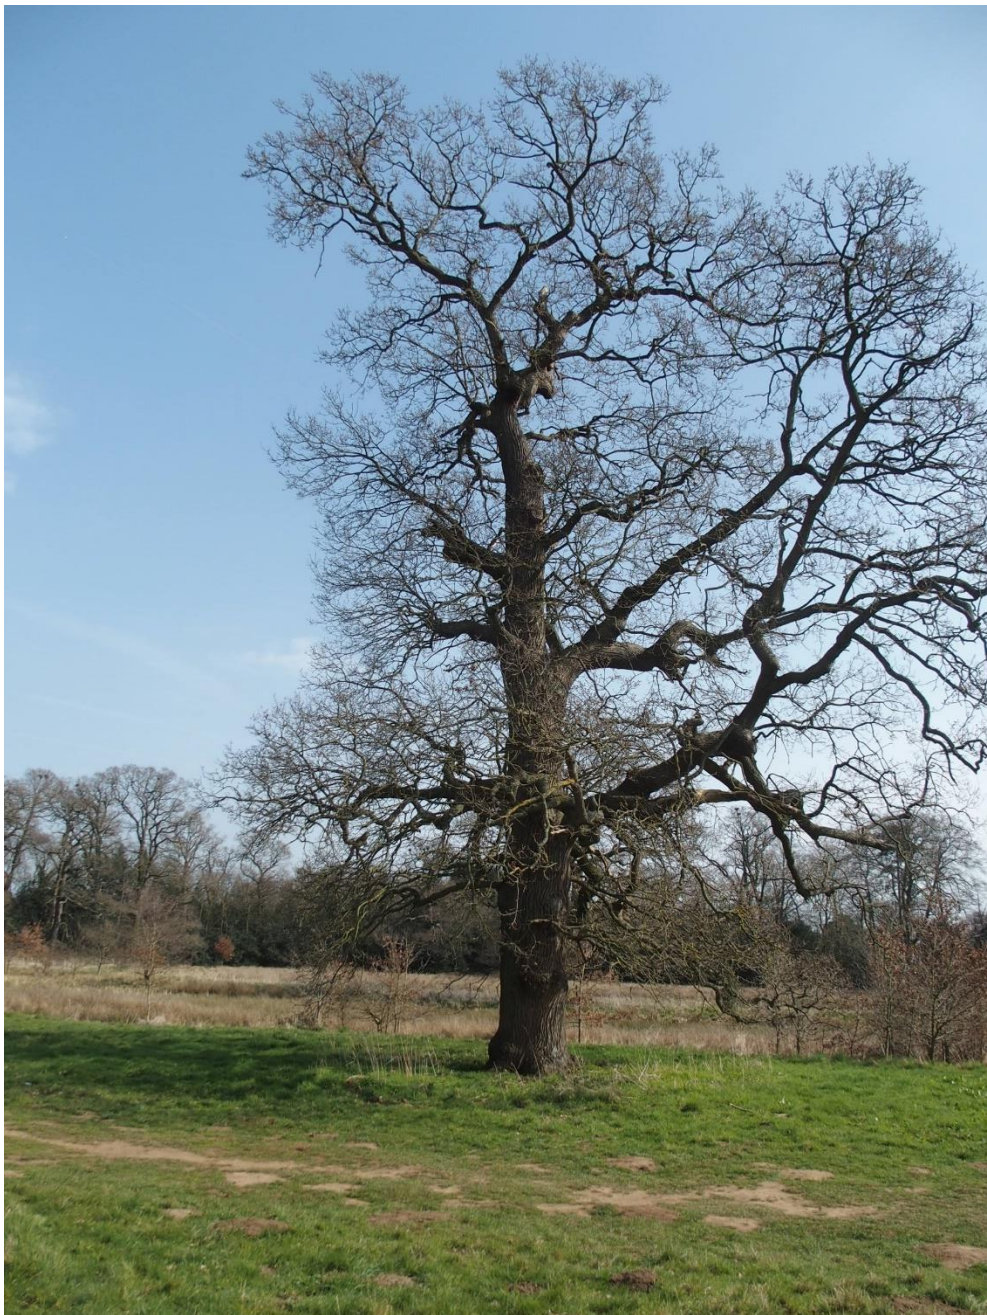
- 9.8 This is an example, a veteran oak tree (*Quercus robur*) (Tree No 45) from the first phase of the history of Flitwick park, **Phase 1**, and is probably an old hedgerow tree.

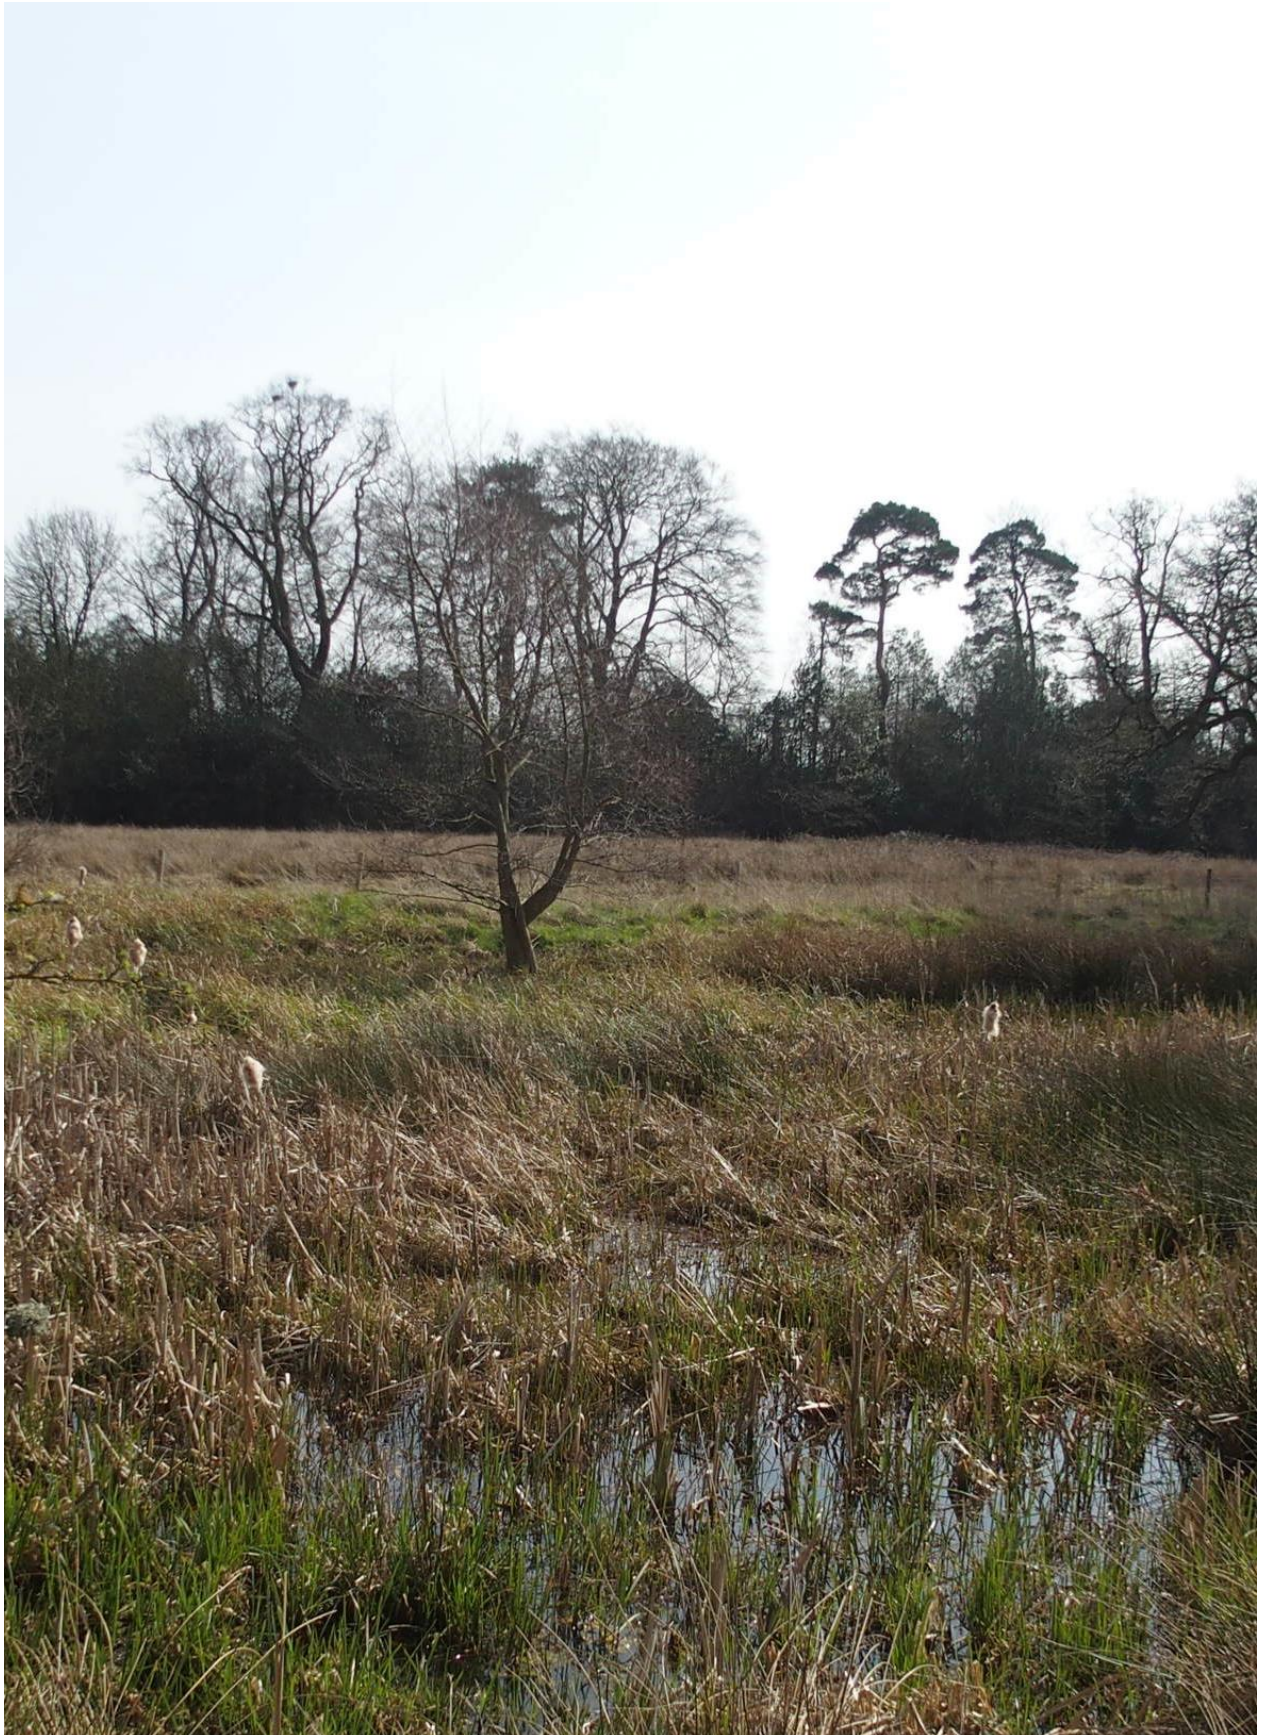
- 9.9 This is an example, a Monterey pine (*Pinus radiata*), (Tree No 106) from the second phase of development of, **Phase 2**, of the park and is one of many exotic conifers probably planted by JT Brooks between 1816 and 1858 as he developed the arboretum.

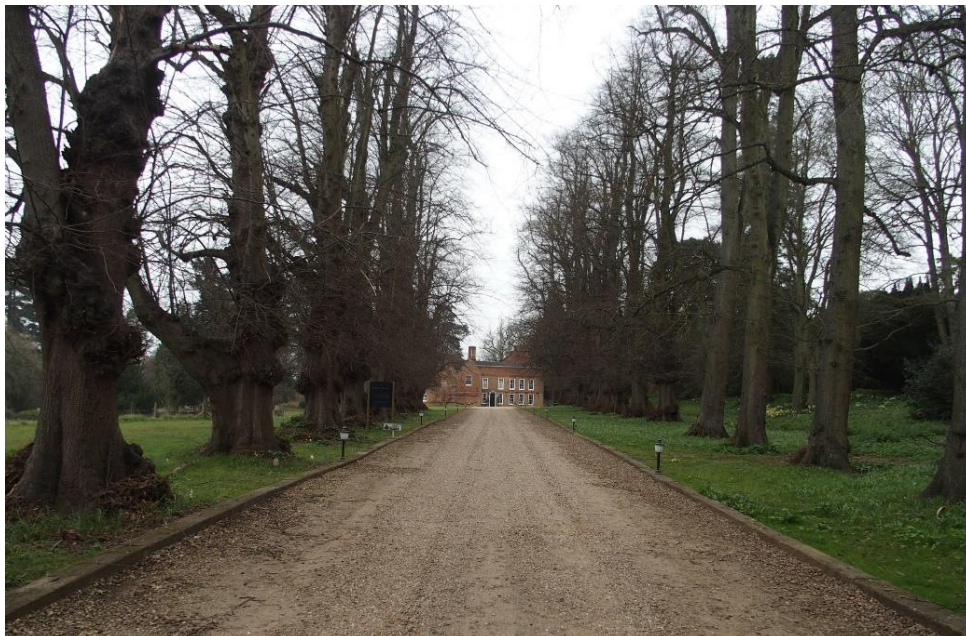
- 10.11 This feature remains intact as single avenue of mature limes marked on the 1838 plan as number 45: Board Walk and Lime Avenue. The avenue is in good condition and frames the view of the house successfully from the main entrance gates. See photo below.

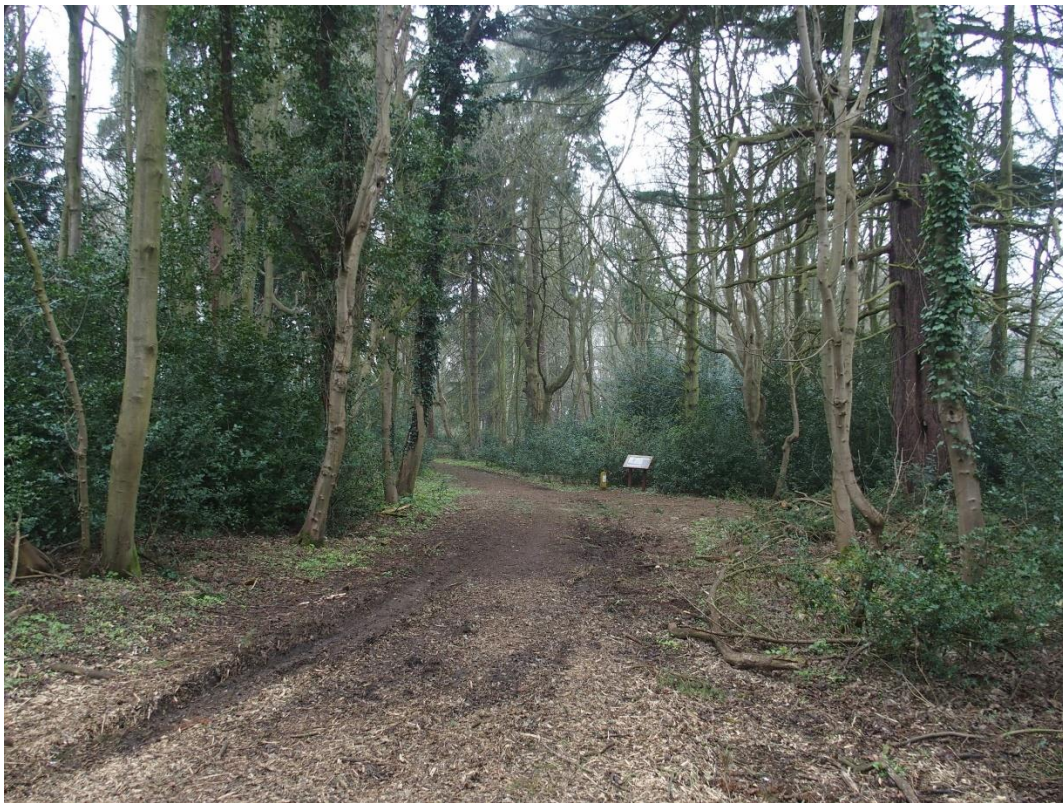
- 10.13 The drive from Lower Lodge, through 6 Evergreen Drive, was previously the route of a public road before it was successfully diverted by John Brookes in 1829. The route is still traceable as an earthwork (see photo below) although the surface has long since disappeared. Significantly, there are no regenerating trees which have been allowed to develop on the line of the drive.

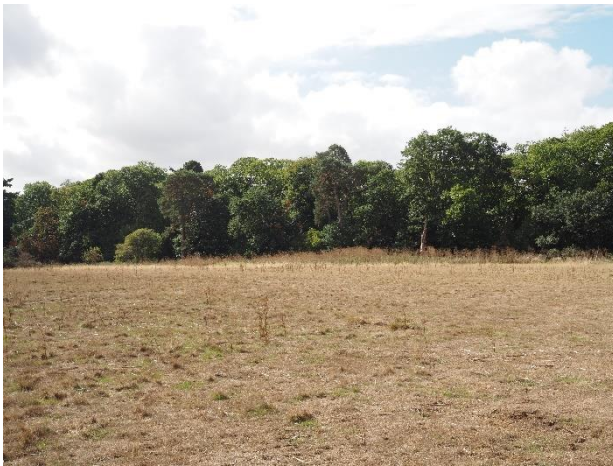
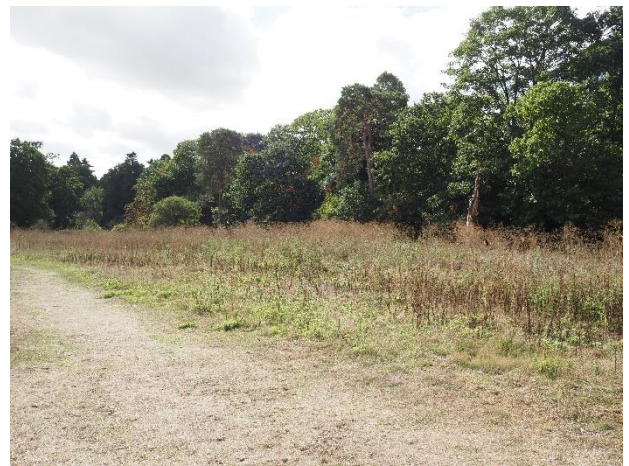
**Photo 1, 2 , 3 and 4. Impermeable arboretum edge could be improved by managing sward, crown raising and thinning and replanting with new conifers . Photos 3 and 4 below show the nature of the view looking out with dense stands of sycamore.**

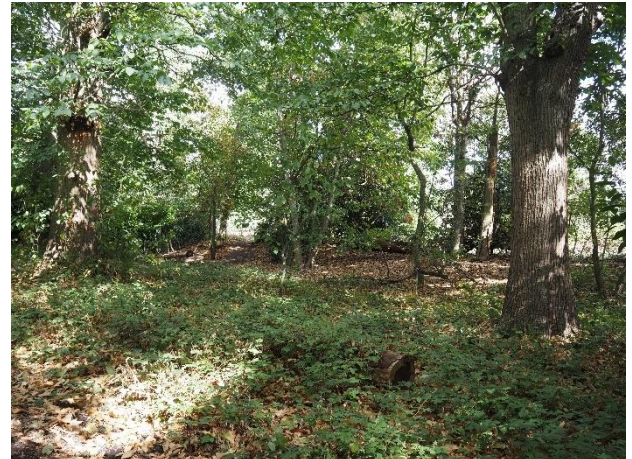
**Photos 5 and 6 below illustrate how existing clearings could be enlarged through clearance of shrubs, bramble and sycamore to create large open areas for replanting of exotic conifers at wide spacing. Existing arboretum trees would be seen more clearly**

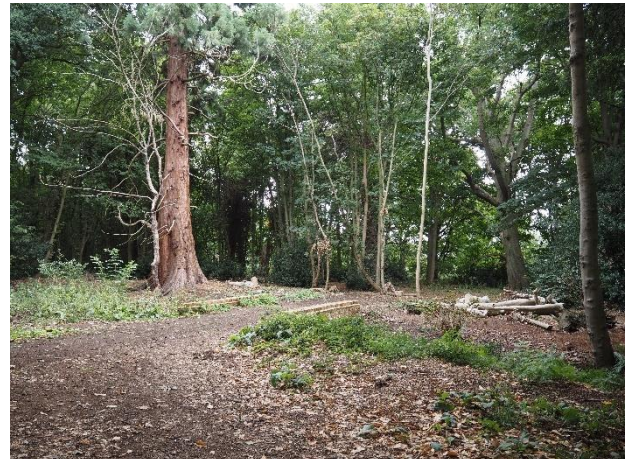
**Photos 7 and 8 illustrate the need for thinning. In the case of Photo 7 the dense evergreen screen of yews and evergreen oak is encroaching onto the path and Photo 8 illustrates the suffocating nature of unlimited sycamore regeneration**

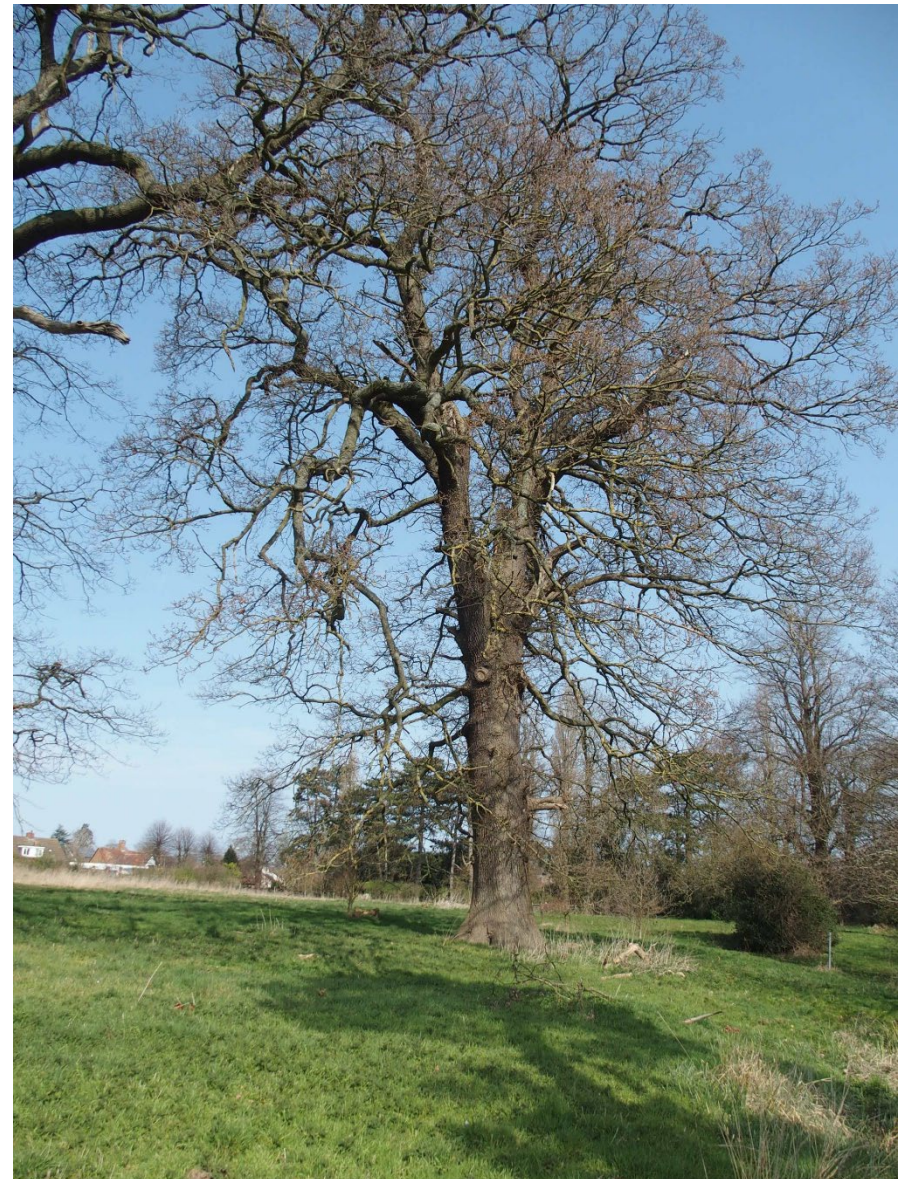
Number	45 (1639)
Grid Ref	
Species English	Oak
Species Latin	Quercus robur
Dia	124cm
Est Ht	20
Tree form	Full
Standing/Fallen	St
Live Growth	1
Crown Loss	1
Bark Loss/Loose Bark	0
Sap runs/Bark Fluxes	0
Crevices (Tears/Scars)	5T
Cavities hollowing Base	0
Cavities hollowing Middle	0
Cavities hollowing Top	0
Cavities hollowing Crown	0
Water Pockets	0
Decay holes	3
Physical Damage	1
Rot	0
Deadwood Attached	10
Deadwood Fallen	-
Fungi	-
Epiphytes	A
Invertebrates	-
